**UPPER ROCK CREEK WATERSHED
SITE #05**

**PHASE I INSPECTION REPORT
NATIONAL DAM INSPECTION PROGRAM**

UPPER ROCK CREEK WATERSHED SITE #5
(LAKE NEEDWOOD)
MONTGOMERY COUNTY, MARYLAND
(NDI-MD-MD-00046)

NAME OF DAM: Upper Rock Creek Watershed Site #5 (Lake Needwood)
STATE: Maryland
COUNTY: Montgomery
STREAM: Upper Rock Creek
DATE OF INSPECTION: June 15, 1979

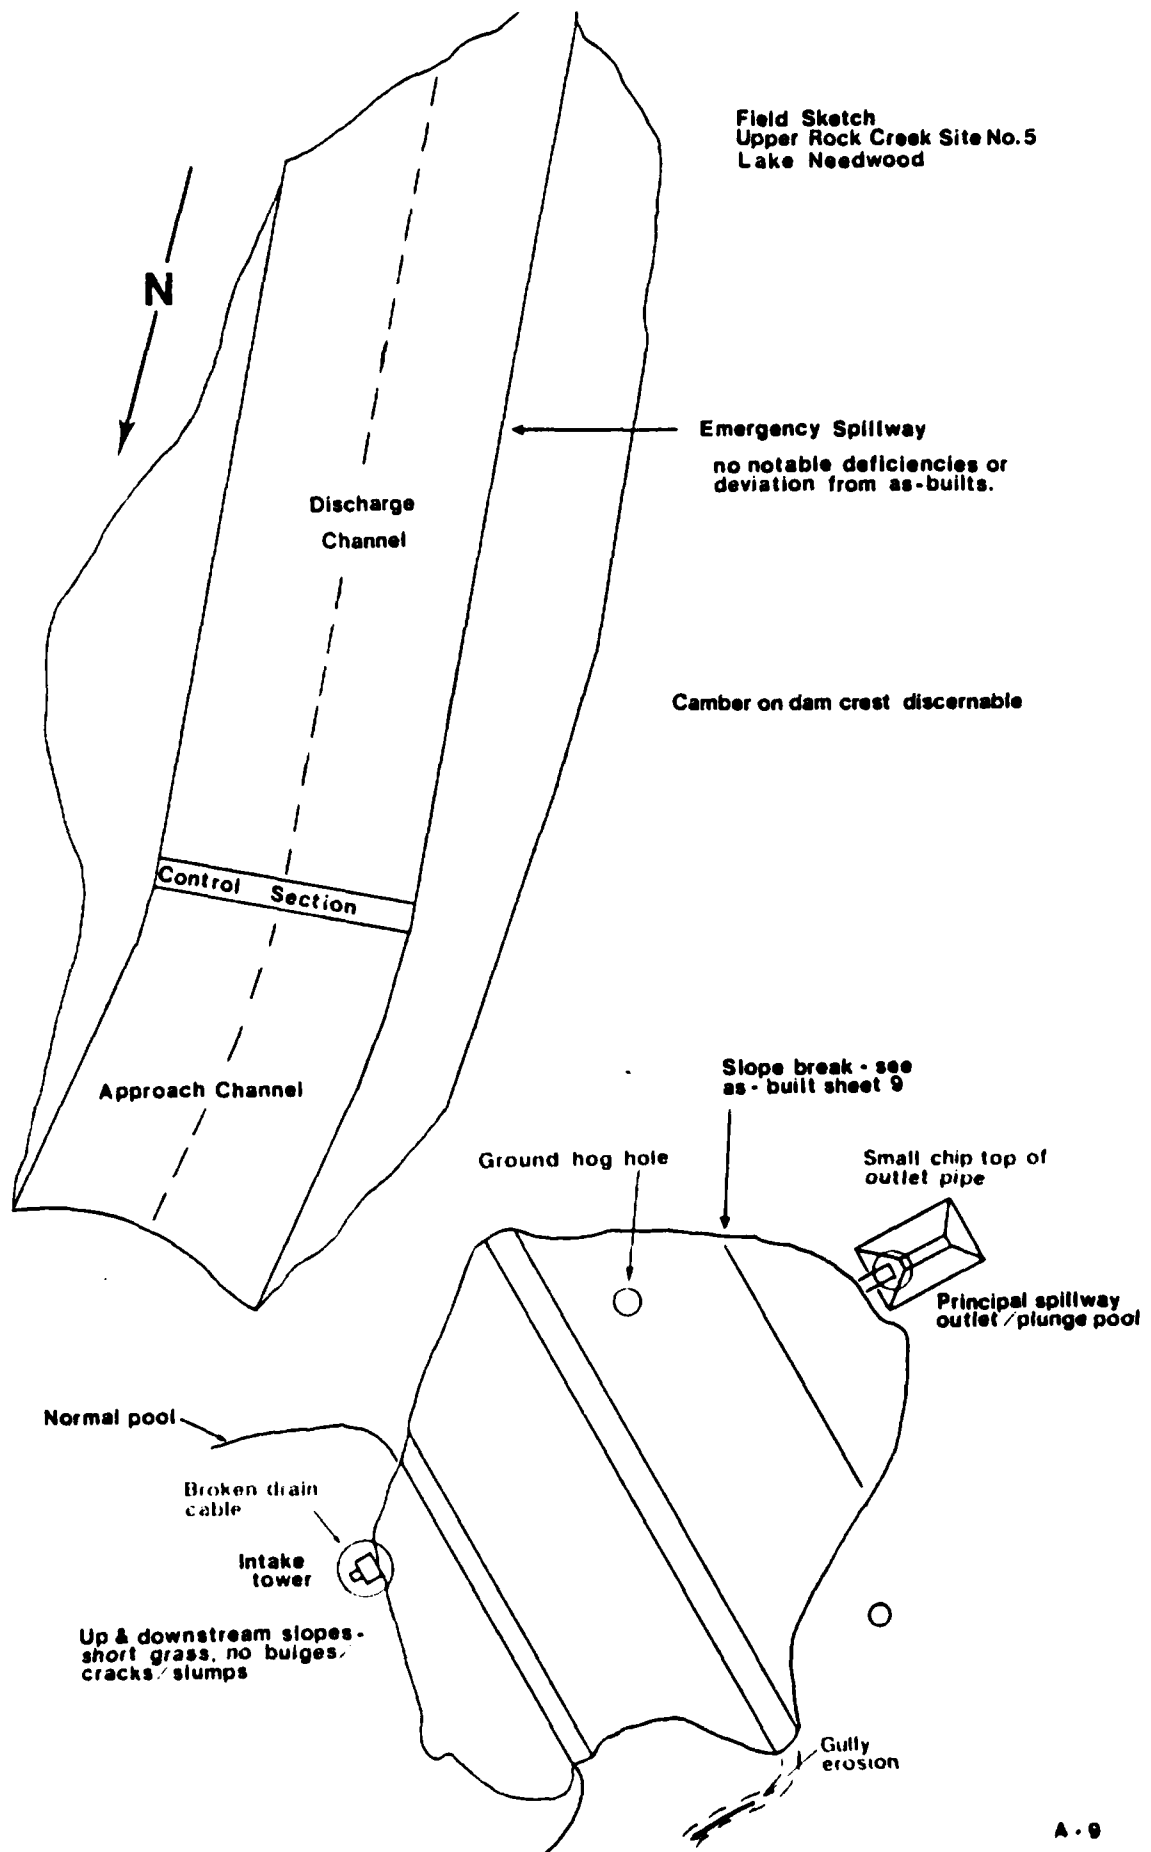
Field Sketch
Upper Rock Creek Site No.5
Lake Needwood

VISUAL EXAMINATION OF	OBSERVATIONS AND REMARKS/RECOMMENDATIONS
CRACKING AND SPALLING OF CONCRETE SURFACES IN OUTLET CONDUIT	None
INTAKE STRUCTURE	No cracking or spalling
OUTLET STRUCTURE	No discernable deflection, see site sketch for chipping pipe top.
OUTLET CHANNEL	Well vegetated channel bank.
EMERGENCY GATE (DRAIN)	Cable broken
